Technical Maintenance of Pole Mounted Circuit Breaker (PMCB) on the Tanjung Tembaga Feeder at PT PLN (Persero) ULP Probolinggo Distribution Network

The reliability of electrical distribution systems is critically dependent on the performance of protection devices such as the Pole Mounted Circuit Breaker (PMCB). This study focuses on the maintenance and performance evaluation of the PMCB installed on the Tanjung Tembaga feeder operated by PT PLN (Persero) ULP Probolinggo. The evaluation process involved a series of tests, including trip current and response time measurements, alongside supporting measurements on the Vacuum Circuit Breaker (VCB). The test results revealed that while trip current values slightly exceeded the standard of 15 A, they remained within acceptable technical limits. However, two out of three tests recorded trip times of 2 seconds, far above the standard maximum of 50 milliseconds, indicating a significant delay in fault response. In contrast, the VCB demonstrated optimal performance, with a contact resistance of 95 $\mu\Omega$, an operational voltage of 110 VDC, and an insulation resistance of 1100 M Ω . These findings suggest that although the PMCB remains

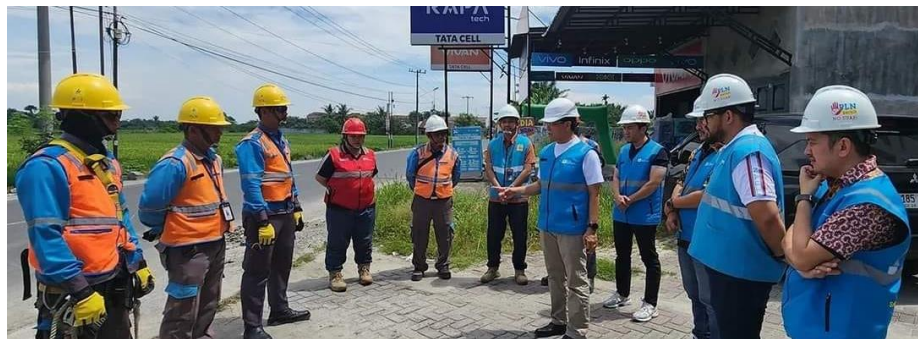
Figure 1. Preparation for Maintenance Ceremony

The initial step in performing PMCB (Pole Mounted Circuit Breaker) maintenance begins with the issuance of a Permit to Work (PTW) document. This document outlines the scheduled power outage and defines the scope of the maintenance activities to be undertaken. Following this, a detailed work plan is developed, listing specific tasks, required tools, and the timeline for execution. Equipment and material preparation includes essential instruments such as multimeters, lubricants, spare parts (e.g., springs, batteries, and LCD units), and cleaning supplies [Figure 1](#).

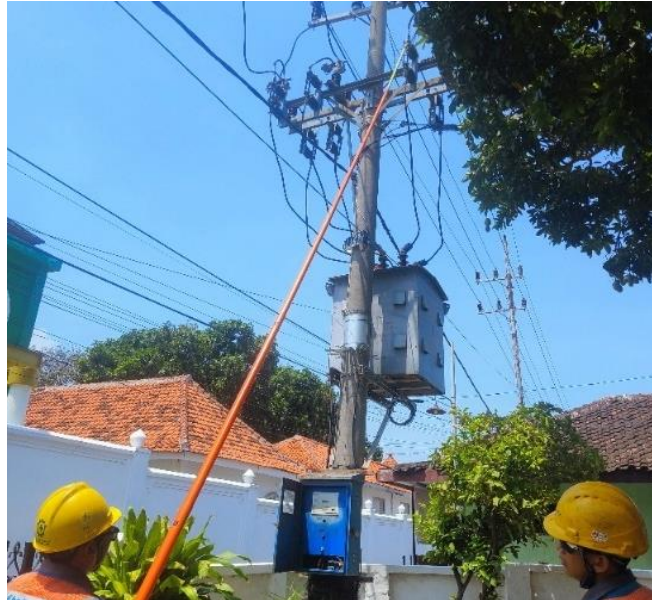
Figure 2. Power Disconnection Process

The initial step in performing PMCB (Pole Mounted Circuit Breaker) maintenance begins with the issuance of a Permit to Work (PTW) document. This document outlines the scheduled power outage and defines the scope of the maintenance activities to be undertaken. Following this, a detailed work plan is developed, listing specific tasks, required tools, and the timeline for execution. Equipment and material preparation includes essential instruments such as multimeters, lubricants, spare parts (e.g., springs, batteries, and LCD units), and cleaning supplies [Figure 2](#).

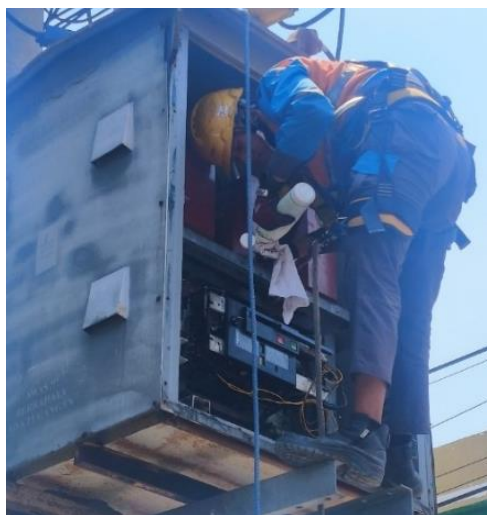
Figure 3. Dust and Rust Cleaning

Once safety has been ensured, the next step involves a thorough visual inspection and cleaning of the PMCB components. The cleaning process includes removing accumulated dust and rust from electrical contacts and insulators using specialized cleaning agents that do not damage the component surfaces. This step is critical for maintaining electrical conductivity and preventing flashovers or arcing caused by surface contaminants or corrosion. In addition to surface cleaning, the mechanical components such as springs and levers are examined for signs of wear or physical damage that could impair the breaker's operation. Any worn or damaged parts must be replaced immediately to ensure that the PMCB maintains its protective function and can respond effectively to faults in the electrical distribution network **Figure 3.**

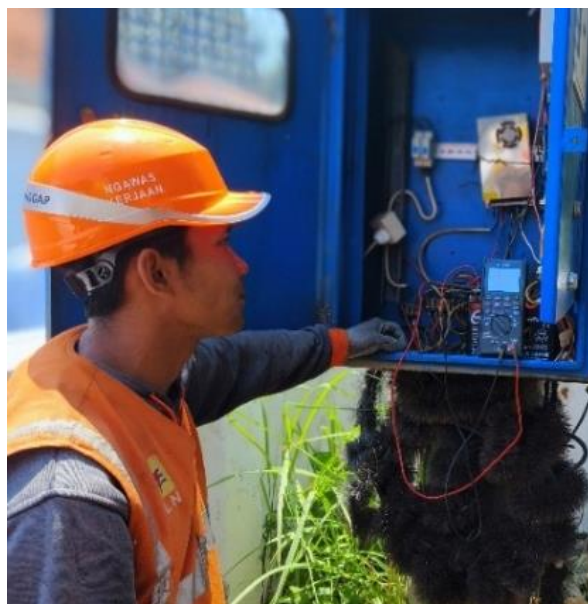
Figure 4. Dust and Rust Removal

The maintenance of the PMCB involves inspecting its supporting electronic components, particularly the battery and LCD display. The battery is evaluated to ensure its voltage remains within the acceptable range to adequately support the protection system's operations. If a drop in capacity or abnormal voltage is detected, immediate replacement is necessary to prevent failure in the trip mechanism. Furthermore, the LCD is visually examined to verify its proper functionality, including the clarity and visibility of the displayed data. If cracks, blackouts, or unreadable displays are observed, the LCD must be replaced to ensure that the PMCB's operational status can be monitored accurately by technicians. This inspection of both components is crucial for maintaining the reliability of the PMCB's control and monitoring systems, and to ensure prompt response in the event of electrical faults **Figure 4**.

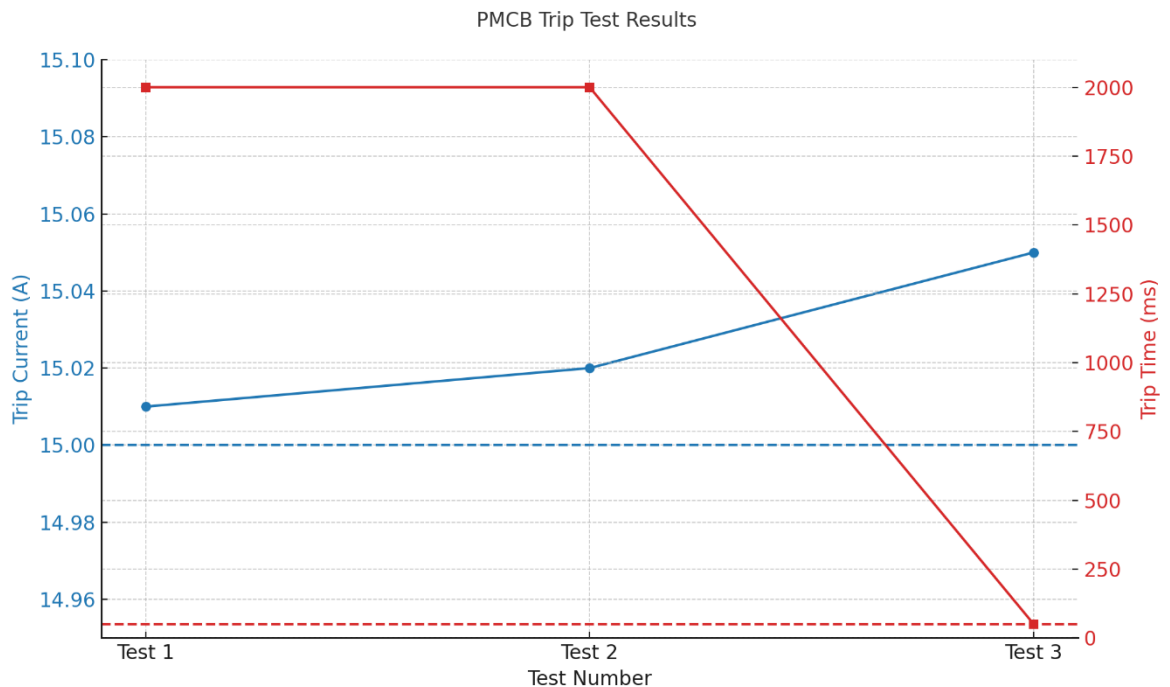
Figure 5. PMCB Trip Test Results

Based on the results of the PMCB (Pole Mounted Circuit Breaker) performance tests conducted three times, as shown in Table 1, the data reveal notable differences between standard values and actual outcomes in both trip current and trip time. In the first test, the trip current measured 15.01 A, slightly exceeding the standard value of 15 A, though still within acceptable tolerance. However, the recorded trip time was 2 seconds, which is significantly longer than the maximum standard of ≤ 50 milliseconds, thus failing to meet performance criteria.

The second test yielded similar results, with a trip current of 15.02 A—again marginally above the standard yet acceptable. However, the trip time remained at 2 seconds, again falling short of the technical requirements. In contrast, the third test

reported a trip current of 15.05 A, slightly above the nominal but still acceptable, with a trip time of 50 milliseconds, which precisely meets the required performance threshold. Therefore, only the third test fully satisfies the protection criteria in terms of both current and timing parameters.

Based on the trip test graph for the PMCB (Pole Mounted Circuit Breaker), it is observed that the trip current values in all three tests are consistently slightly above the nominal standard of 15 A. Although these deviations exist, they remain within tolerable limits for the protection system, indicating that the PMCB is still performing with acceptable accuracy in terms of current interruption capability. However, a significant discrepancy is observed in the trip time results. In two out of the three tests, the PMCB recorded a trip time of 2000 milliseconds (2 seconds), which far exceeds the maximum response time standard of 50 milliseconds. This significant delay suggests a potential issue with the actuator mechanism or release system of the PMCB, which fails to respond quickly enough to ensure proper system protection.

While the third test showed compliance with the trip time standard, this inconsistency in performance raises concerns about the overall reliability of the PMCB. Both mechanical and control components of the system should be thoroughly

evaluated. The graphical data imply that the PMCB's responsiveness to faults is not yet consistently stable, highlighting the necessity of regular maintenance and system calibration to ensure the continued optimal function of this protection equipment.

Based on the results of the study and testing conducted on the Pole Mounted Circuit Breaker (PMCB) located on the Tanjung Tembaga feeder, it can be concluded that, in terms of trip current measurement, all three tests produced values slightly above the standard threshold of 15 A, yet still within acceptable technical tolerance limits. However, the trip time results revealed a significant discrepancy in two out of the three tests, where the recorded trip time was 2 seconds—far exceeding the maximum allowable limit of 50 milliseconds. Only one of the tests met the expected response time criteria. These findings indicate that while the PMCB's current interruption capability is within acceptable parameters, the trip mechanism requires further evaluation and improvement. Meanwhile, the measurements taken from the Vacuum Circuit Breaker (VCB) demonstrated satisfactory performance in line with technical standards: a contact resistance of 95 $\mu\Omega$, operational voltage of 110 VDC, and insulation resistance of 1100 M Ω . Therefore, the VCB is considered to be in operable condition. Overall, the findings suggest that while both devices remain functional, recalibration or mechanical adjustments to the PMCB's trip system are necessary to ensure faster and more reliable fault response within the electrical distribution network.
